# Manhole Inspection Summary

Manhole # S21M\_\_045MH

**Location** Address: **436 s payson st** Cross Street: **christian-wilkens alley**

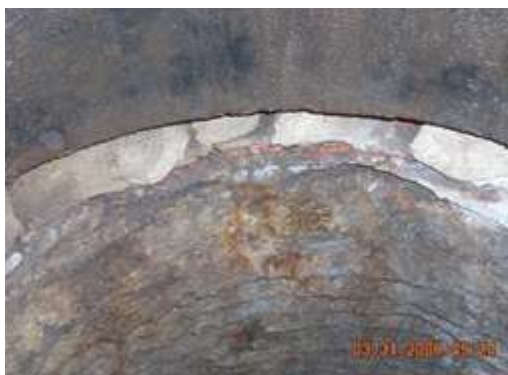
Defect 5

**Chimney / Frame Adjustment** ☒ Exists Material: **Brick and Concrete** ☐ Parged Height: **3** (in.)

Condition: ☐ Sound ☒ **Cracked** ☐ Root Intrusion ☒ **Loose Brick** ☐ Deteriorated

loose concrete chimney

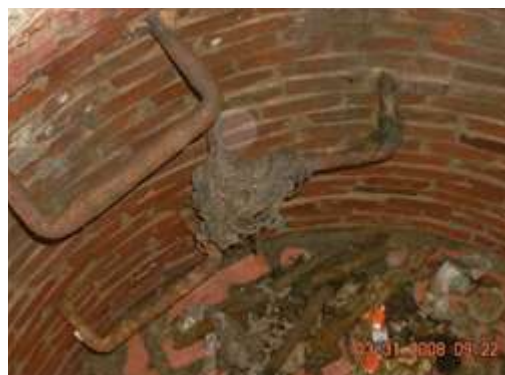
Defect 4

**Surcharge** ☒ **Evidence Of Surcharge** Depth: **4** (ft.) ☐ Active Surcharge Present

surcharge evidence on step

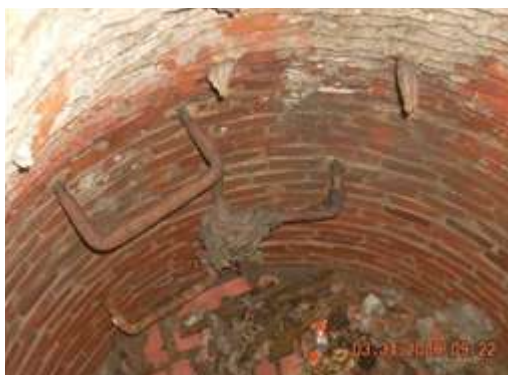
Defect 3

**Steps** Count: **3** Missing: **2** ☒ **Corroded**

corroded/missing steps

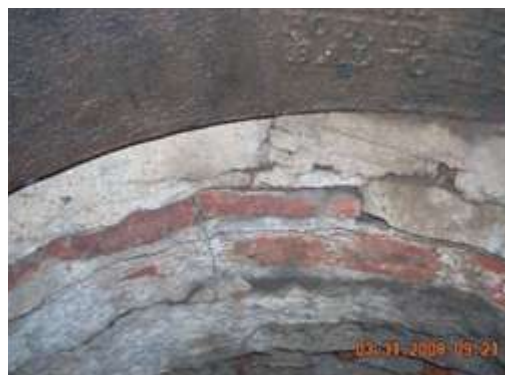
Defect 2

Infiltration: ☐ None ☒ **Joint** ☐ Cracks ☐ Mortar ☐ Roots ☐ Wall

cracked chimney bricks/concrete,  
infiltration @ chimney joint

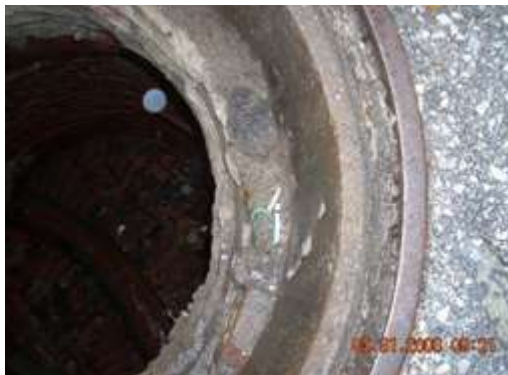
### Defect 1

**Frame** Offset: **3** (in.) Condition: ☒ Sound ☐ Cracked ☐ Leaks

frame offset

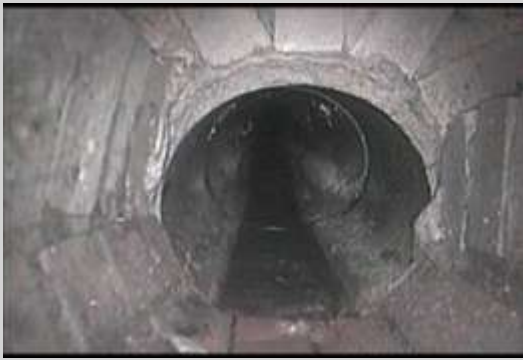
12 O'Clock Outflow

Pipe Height: **8.4** (in.) Rod and Bar (Angled)  
Pipe Material: **Clay** ☐ Pipe Lined  
Invert Depth: **9.20** (ft.) Flow Characteristics: **Slow**  
Deposits: ☒ None ☐ Mud ☐ Sludge ☐ Debris ☐ Grease  
Silt Depth: **0** (in.) Deposits Extent:  
Infiltration: **None** Pipe Seal Cond: **Sound**

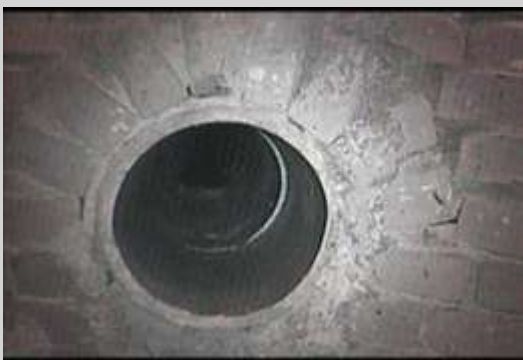
7 O'Clock Inflow

Pipe Height: **8.4** (in.) Rod and Bar (Angled)  
Pipe Material: **Clay** ☐ Pipe Lined  
Invert Depth: **6.79** (ft.) Flow Characteristics: **Slow**  
Deposits: ☒ None ☐ Mud ☐ Sludge ☐ Debris ☐ Grease  
Silt Depth: **0** (in.) Deposits Extent:  
Infiltration: **None** Pipe Seal Cond: **Sound**

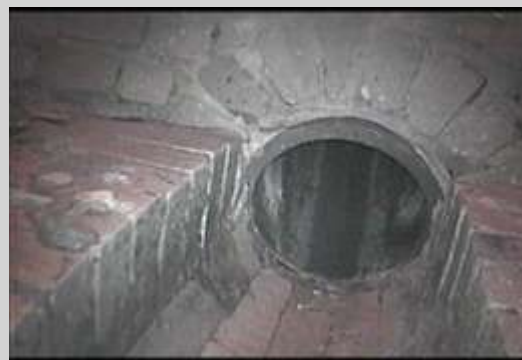
Drop In @ 7 O'Clock

Drop: **Outside** Rod and Bar  
Angled: **Yes** Reading: **7.67** (ft.)  
Inv Depth: **8.67** (ft.)

Drop Condition: **Open**
